## **“As-Built Documentation”:**

Birth Certificate Document and 4 years  
follow up for SCM and Reference walls at  
Aalborg Portland

**Prepared by: Sergio Ferreiro Garzón<sup>1</sup>, Lasse Frølich  
Kristensen<sup>2</sup> and Ulla Hjorth Jakobsen<sup>2</sup>**

<sup>1</sup> Aalborg Portland A/S, <sup>2</sup>Danish Technological Institute

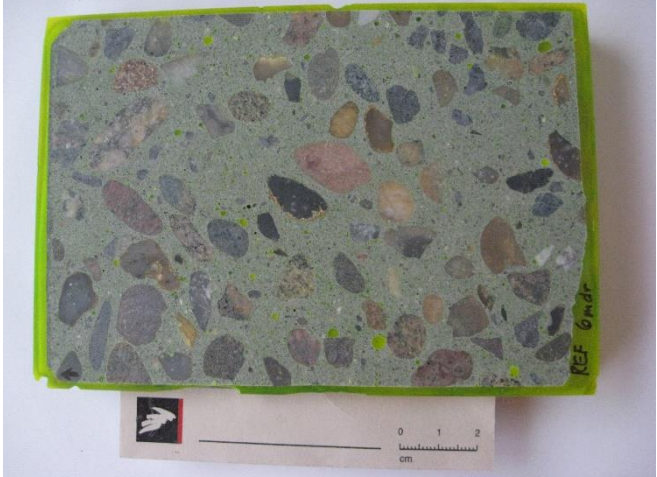
| <p>Cross section of the concrete after epoxy impregnation. Surface to the left.</p> | <p>The same section as to the left, seen in UV-light. Only very few cracks are observed in the concrete.</p> |

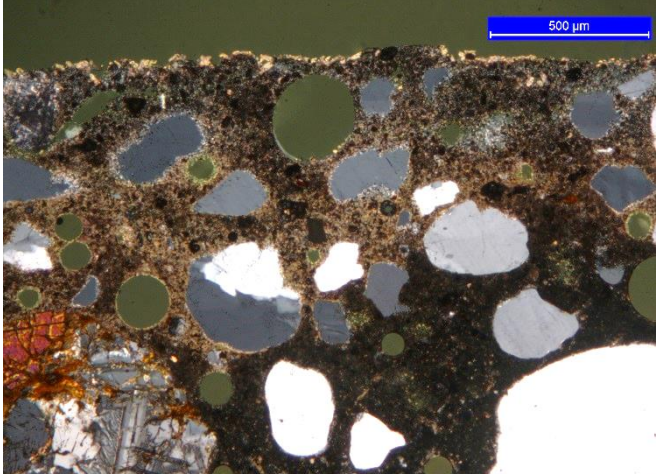
| <p>Small calcite crystals are present on the carbonated concrete surface. X-polarised light.</p> | <p>Small plastic defects are present in the outer 0.8mm of the concrete. Fluorescent light.</p> |

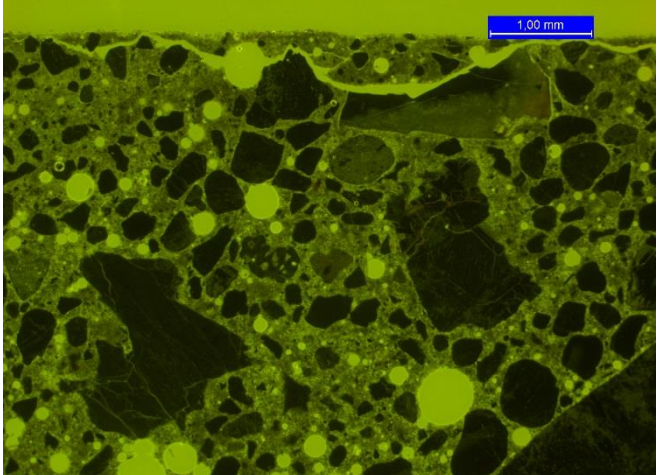
| <p>A surface parallel crack is seen in relation to a reactive flint particle. Fluorescent light.</p> | <p>General texture of the paste containing large crystals of calcium hydroxide. X-polarised light.</p> |

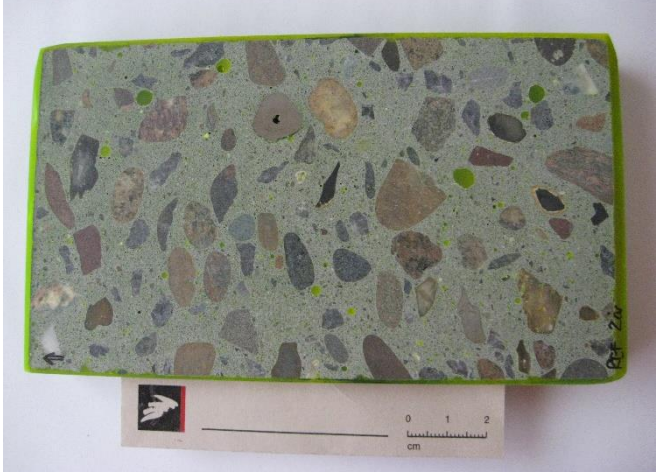
| <p>Cross section of the concrete after epoxy impregnation. Surface to the left.</p> | <p>The same section as to the left, seen in UV-light. Only very few cracks are observed in the concrete.</p> |

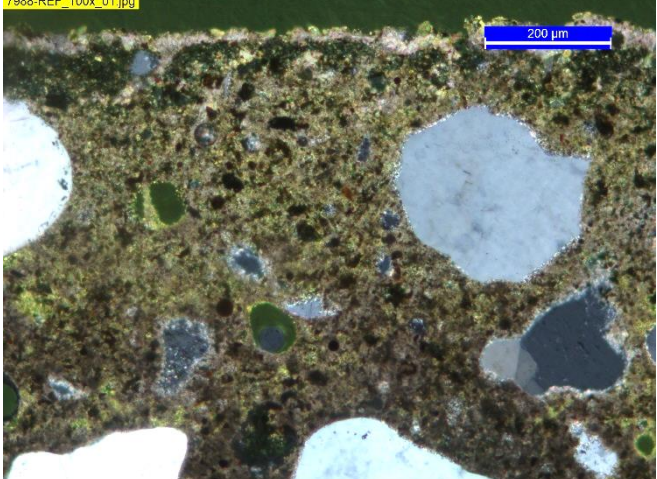
| <p>Small calcite crystals are forming a more or less, intact crust on the carbonated concrete surface. Paste just under crust appears black, leached. X-polarised light.</p> | <p>The carbonated zone appears with an increased porosity. Small plastic defects are present at the interface between porous and denser (opaline paste) paste. Fluorescent light.</p> |

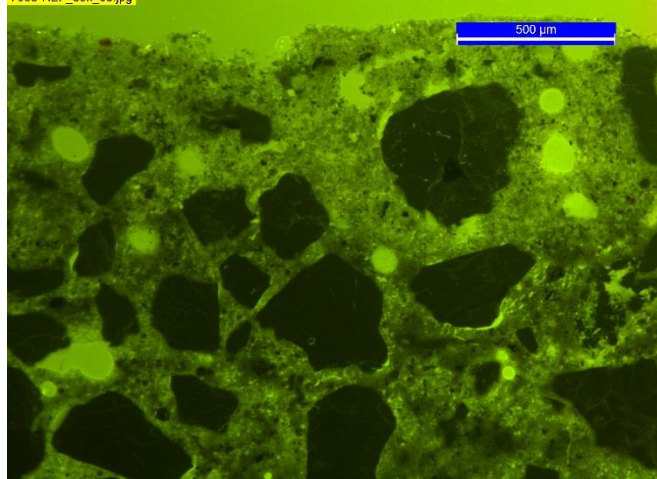
| <p>Plastic paste cracks and adhesion cracks are frequent in the surface region of the concrete. Fluorescent light.</p> | <p>The porous surface region seen in polarised light. The crack visible can be traced to a depth of 6mm.</p> |

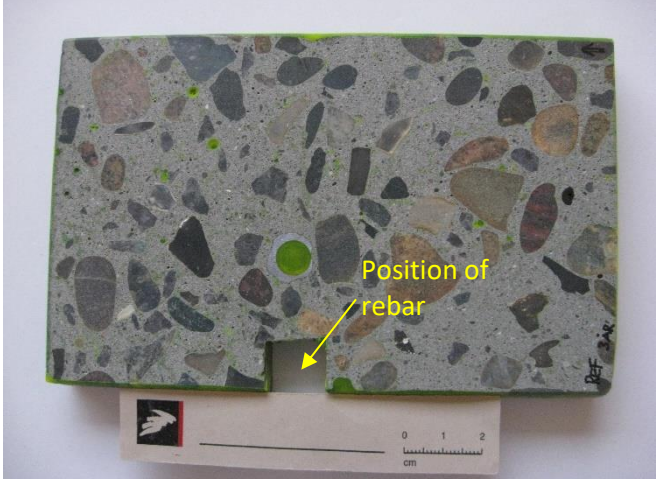
| <p>Cross section of the concrete after epoxy impregnation. Surface to the left.</p> | <p>The same section as to the left, seen in UV-light. Only few micro-cracks are observed in the concrete.</p> |

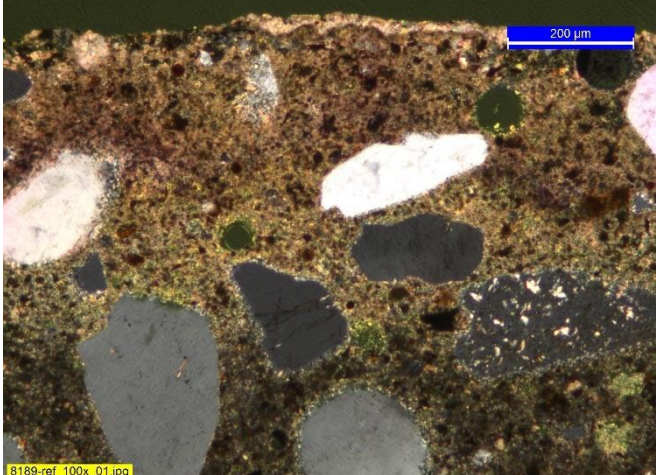
| <p>A thin calcite crust is occasionally covering the carbonated concrete surface. Few places the paste just under the calcite crust appears black, leached. X-polarised light.</p> | <p>The carbonated surface appears with an increased porosity. The interface in front of the carbonated zone is seen as a dense band. Fluorescent light.</p> |

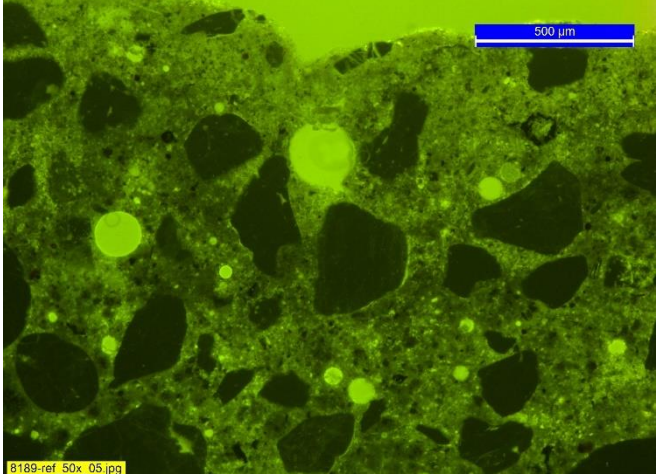
| <p>Plastic adhesion cracks are frequent in the surface region of the concrete. Fluorescent light.</p> | <p>The surface region seen in polarised light. The apparently denser paste under the calcite crust is intensely carbonated.</p> |

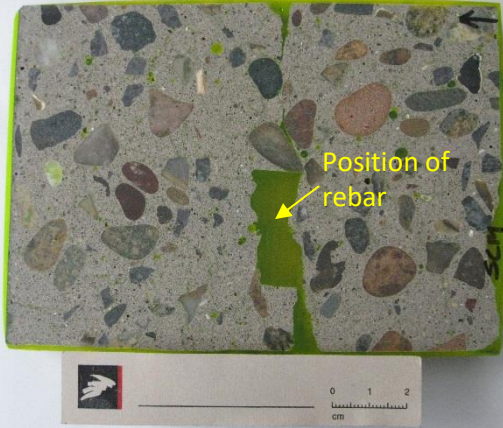
| <p>Cross section of the concrete after epoxy impregnation. A fracture zone is positioned at the level of the rebars. Surface to the left.</p> | <p>The same section as to the left, seen in UV-light. The paste appears rather homogeneous with only few visible cracks.</p> |

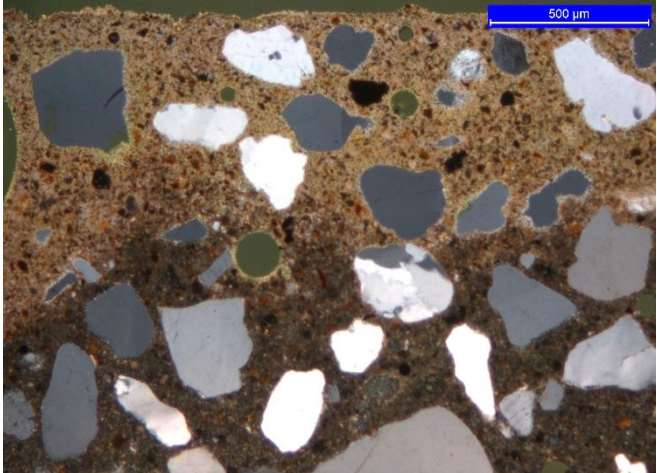
| <p>The concrete surface is extensively carbonated (paste appears brownish). X-polarised light.</p> | <p>A micro-crack is observed within the surface. Variation in the capillary porosity appears in the carbonated area.</p> |

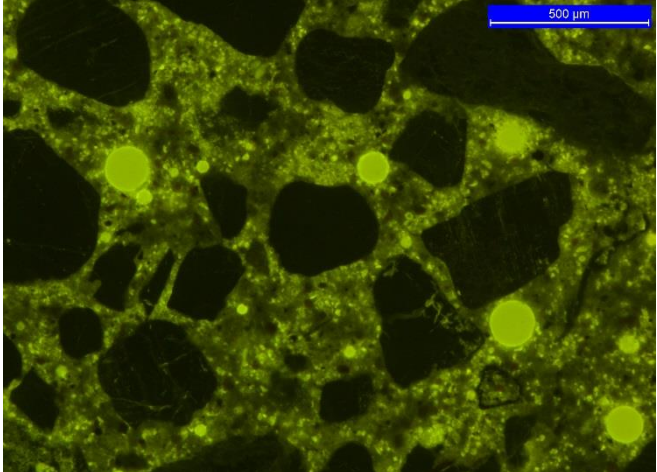
| <p>General appearance of the paste in the interior part of the concrete. Fluorescent light.</p> | <p>The paste appears somewhat opaline, though with visible lime fines and calcined clay (orange). X-polarised light.</p> |

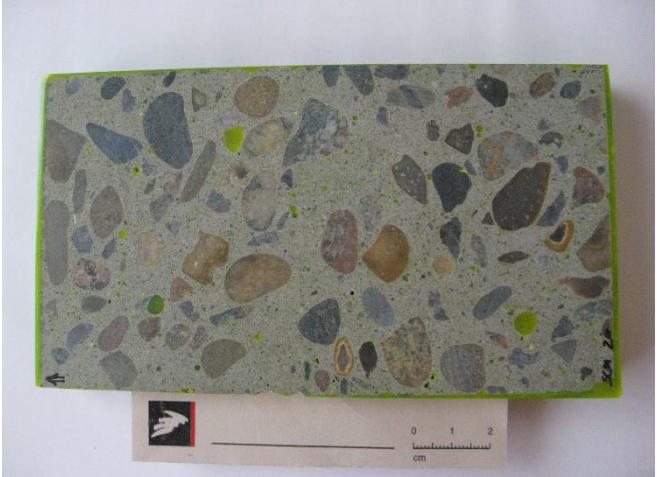
| <p>Cross section of the concrete after epoxy impregnation. Surface to the left.</p> | <p>The same section as to the left, seen in UV-light. Only few microcracks are visible in the concrete.</p> |

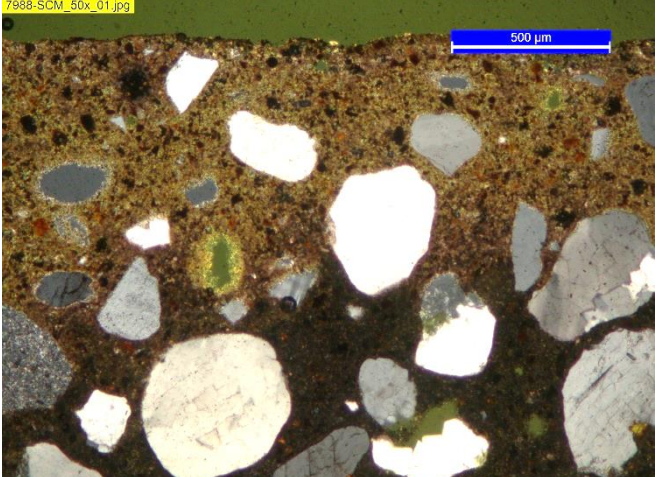
| <p>The concrete surface is extensively carbonated (paste appears brownish). X-polarised light.</p> | <p>The carbonated concrete surface appears highly porous. A dense paste zone is present between the porous surface and the inner denser paste. Fluorescent light.</p> |

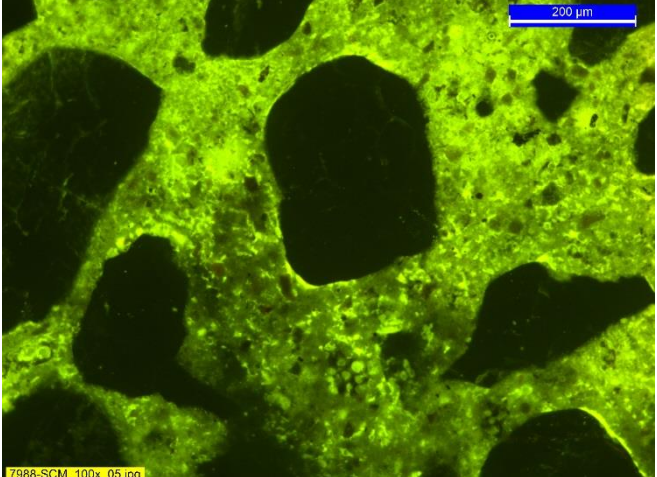
| <p>Plastic paste cracks and adhesion cracks are frequent in the porous carbonated surface region of the concrete. Fluorescent light.</p> | <p>Typical appearance of the paste rich in orange particles of calcined-clay viewed in polarised light.</p> |

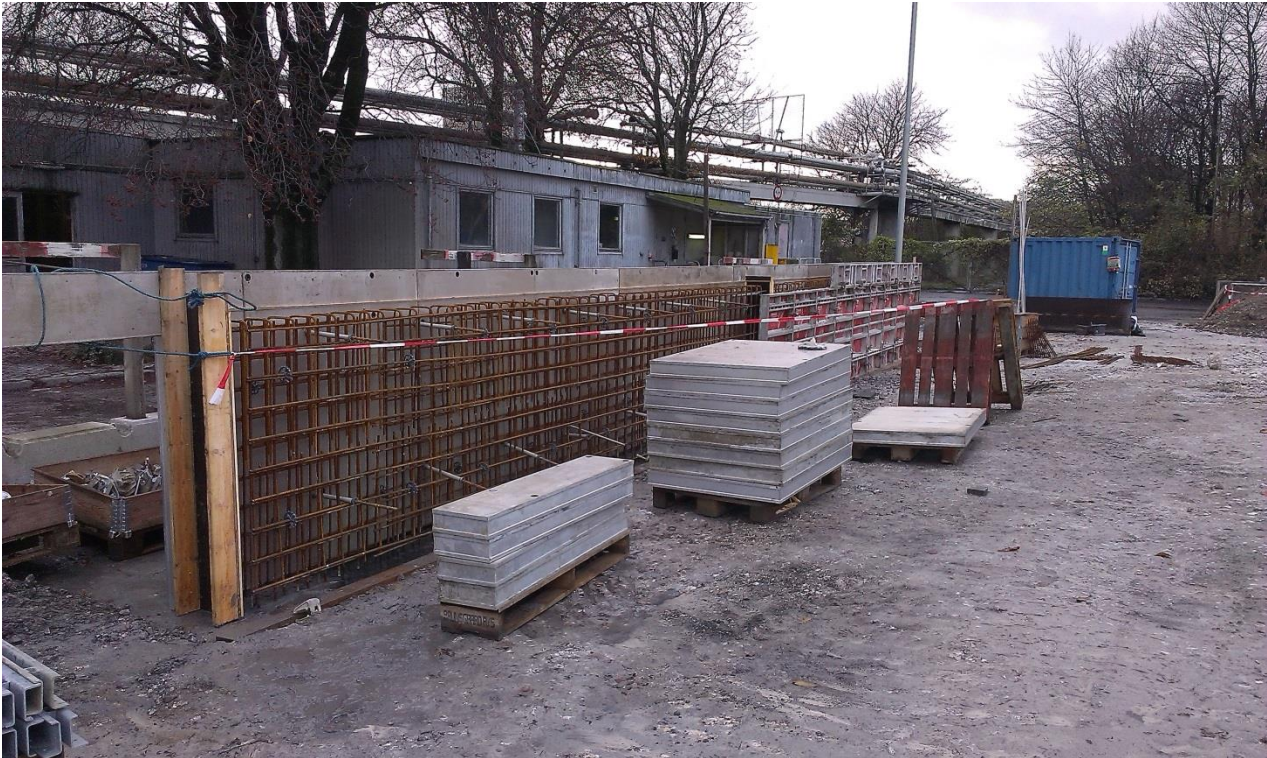
**Figure 3.** Reinforcement and formworks

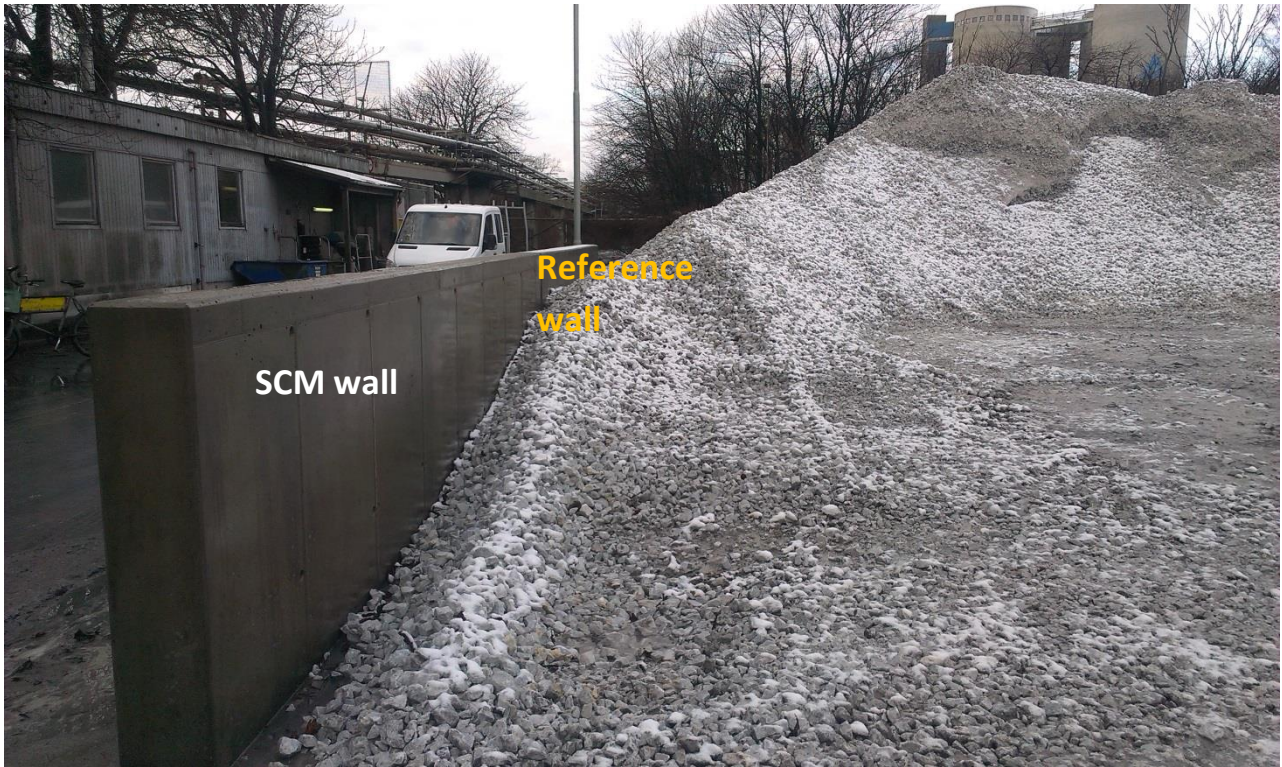
**Figure 5.** Visual aspect of walls on 21-Jan-15

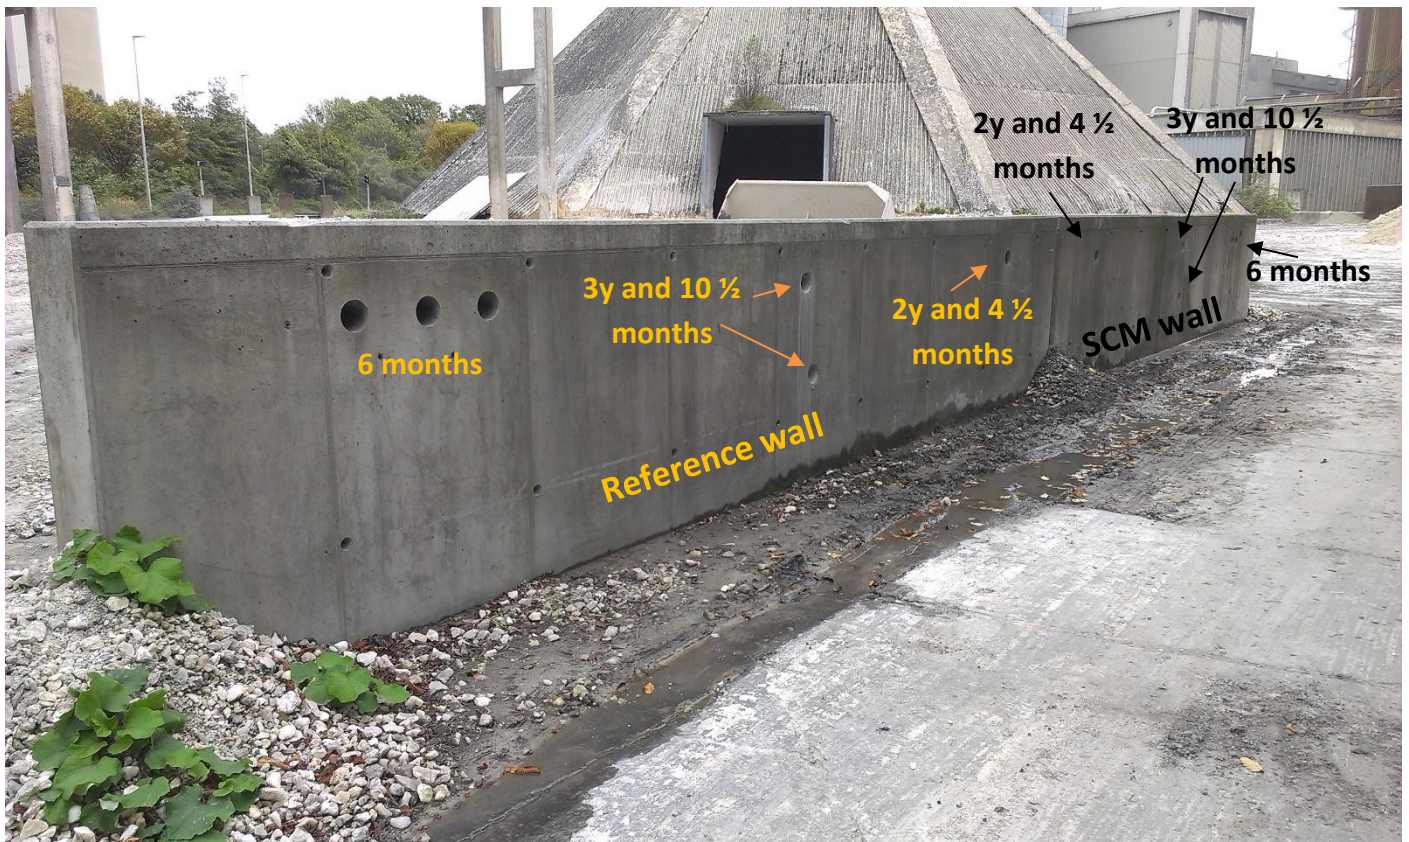
Figure 6. Location of drilled concrete cores and visual aspect of walls on 19-9-18
